October 13, 2011

Subject: DS Tributary (East) Work Plan Letter Report
Detrex Source Control Area – Fields Brook Superfund Site
Detrex Corporation, Ashtabula, Ohio
Docket No. V-W-98-C-450

Detrex Site – FBAG June 2011 Sampling Results DS Tributary (East)

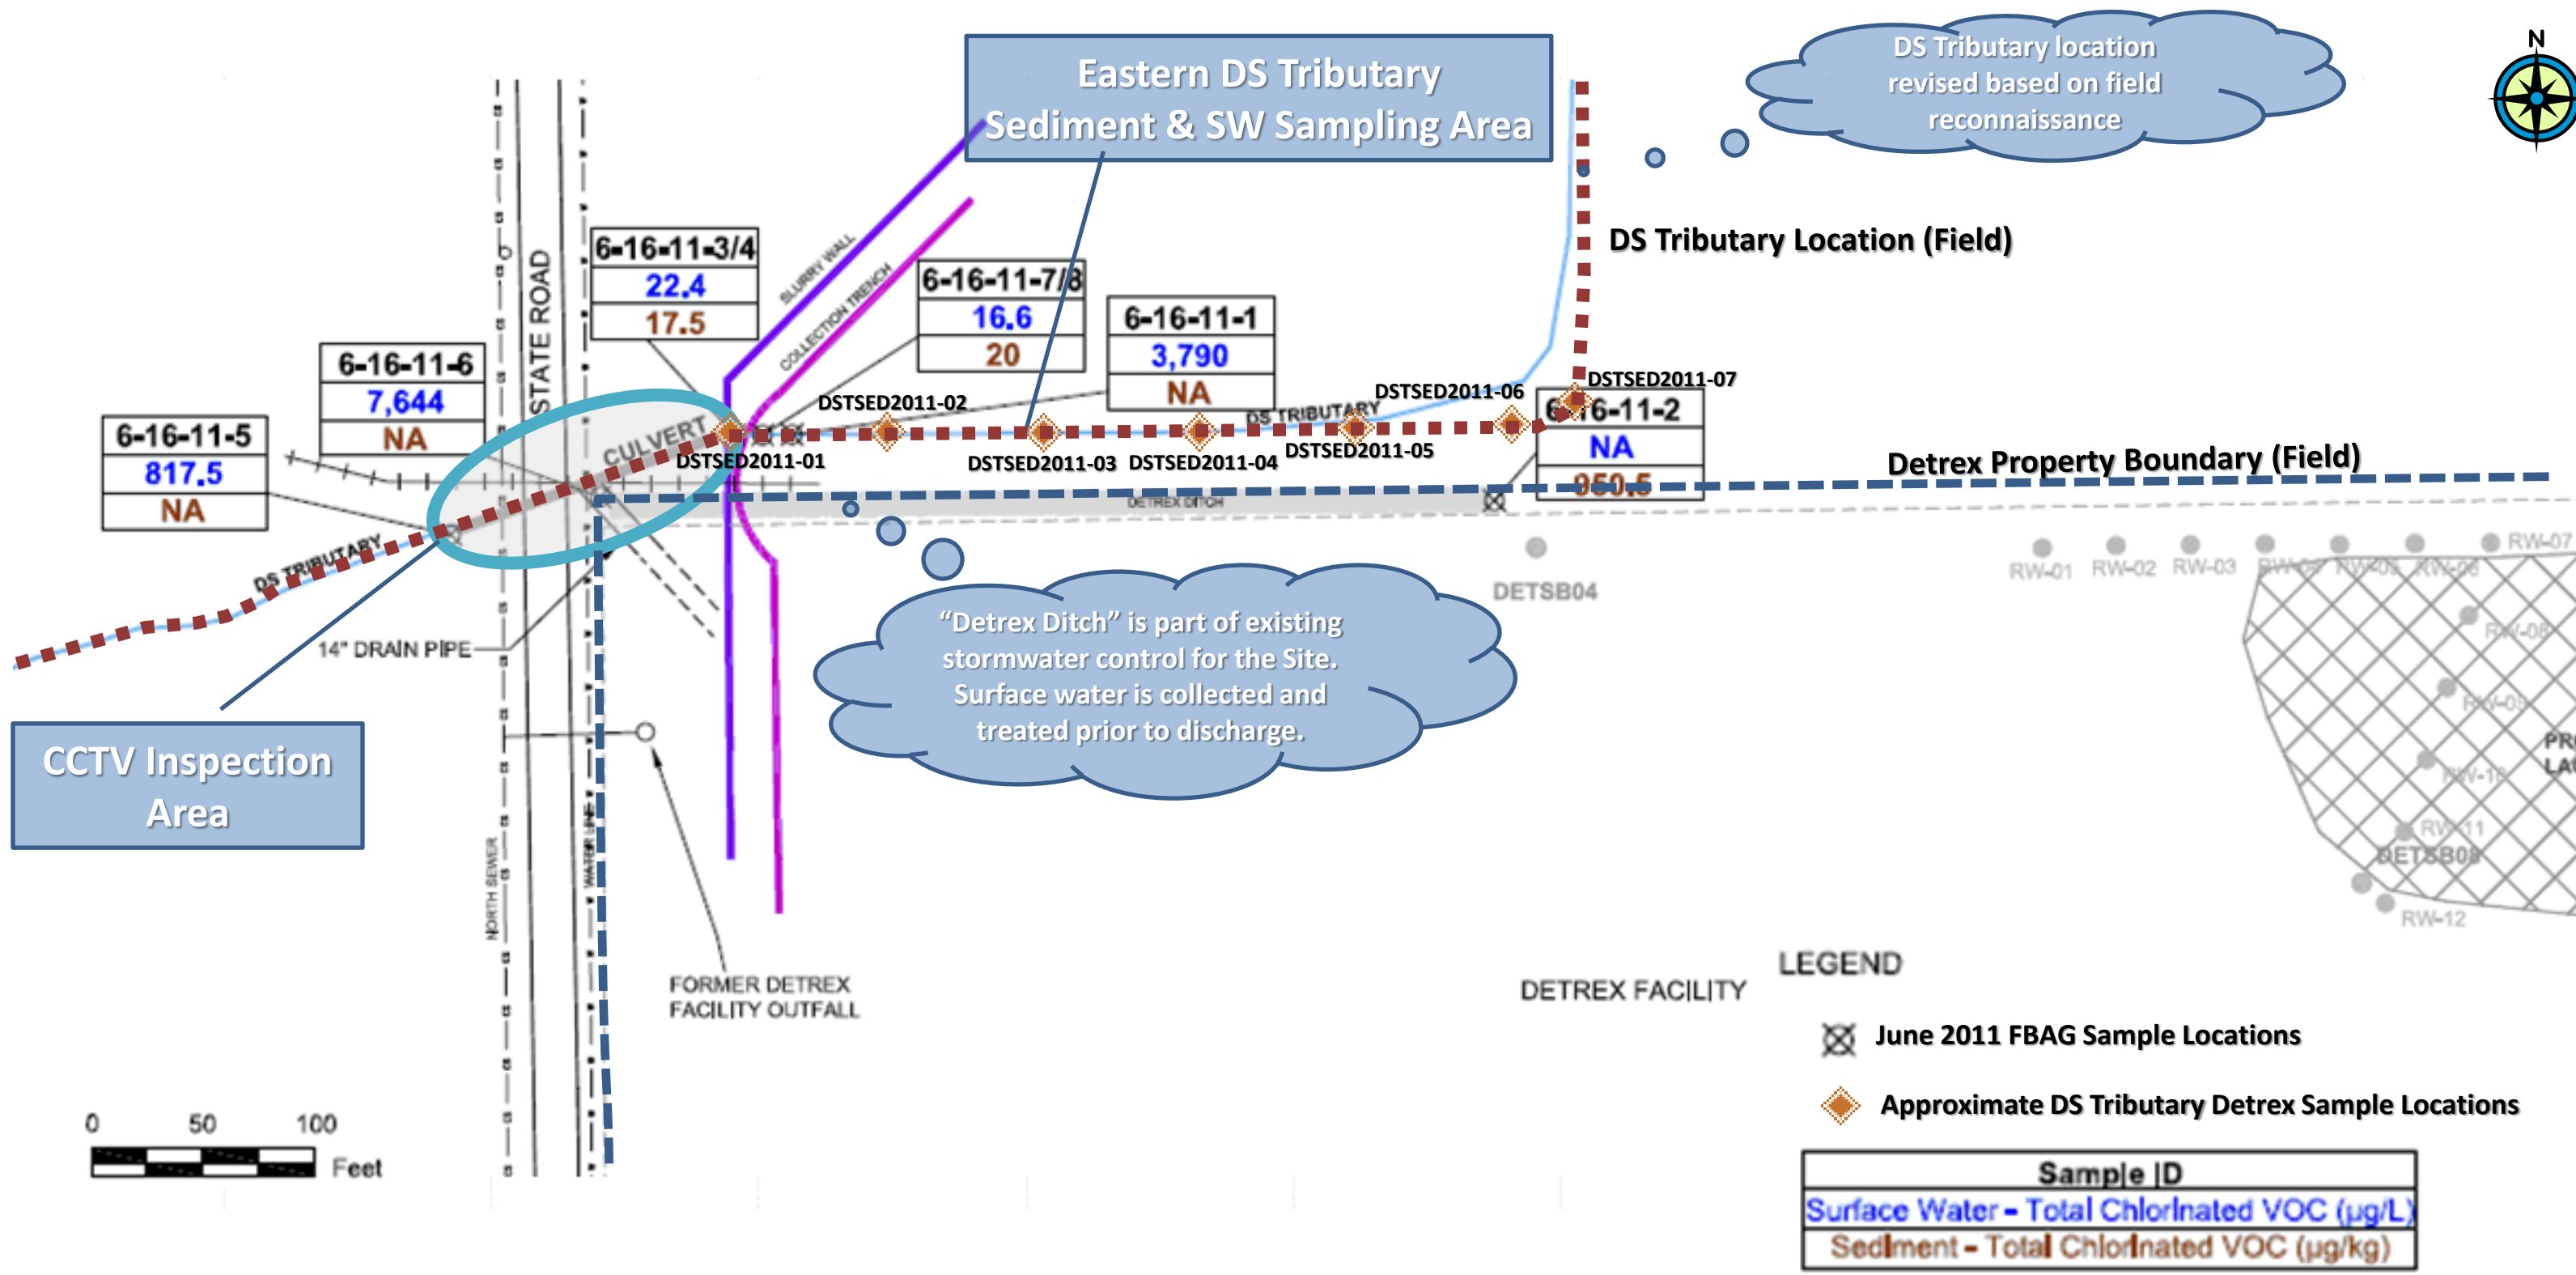
Figure 3

On September 13, 2011, URS conducted surface water and sediment sampling at seven (7) along and within the eastern portion of the DS Tributary. It is noted that six (6) locations were originally scoped in the Addendum; however, based on the field reconnaissance an additional location was required to provide for the sampling of the entire eastern portion of the DS Tributary prior to it turning to the north from the Detrex Site. The completed sampling locations were identified as DST SED 2011-01 through DST SED 2011-07. The sampling locations were equally spaced on approximately 75 foot spacing, with the exception of the final location (DST SED 2011-07) which was approximately 40 ft from the previous sampling location (DST SED 2011-06). The approximate locations of the sediment & surface water sampling locations are depicted in **Figure 3**.

Detrex Site – Completed DS Tributary (East) Investigation Locations

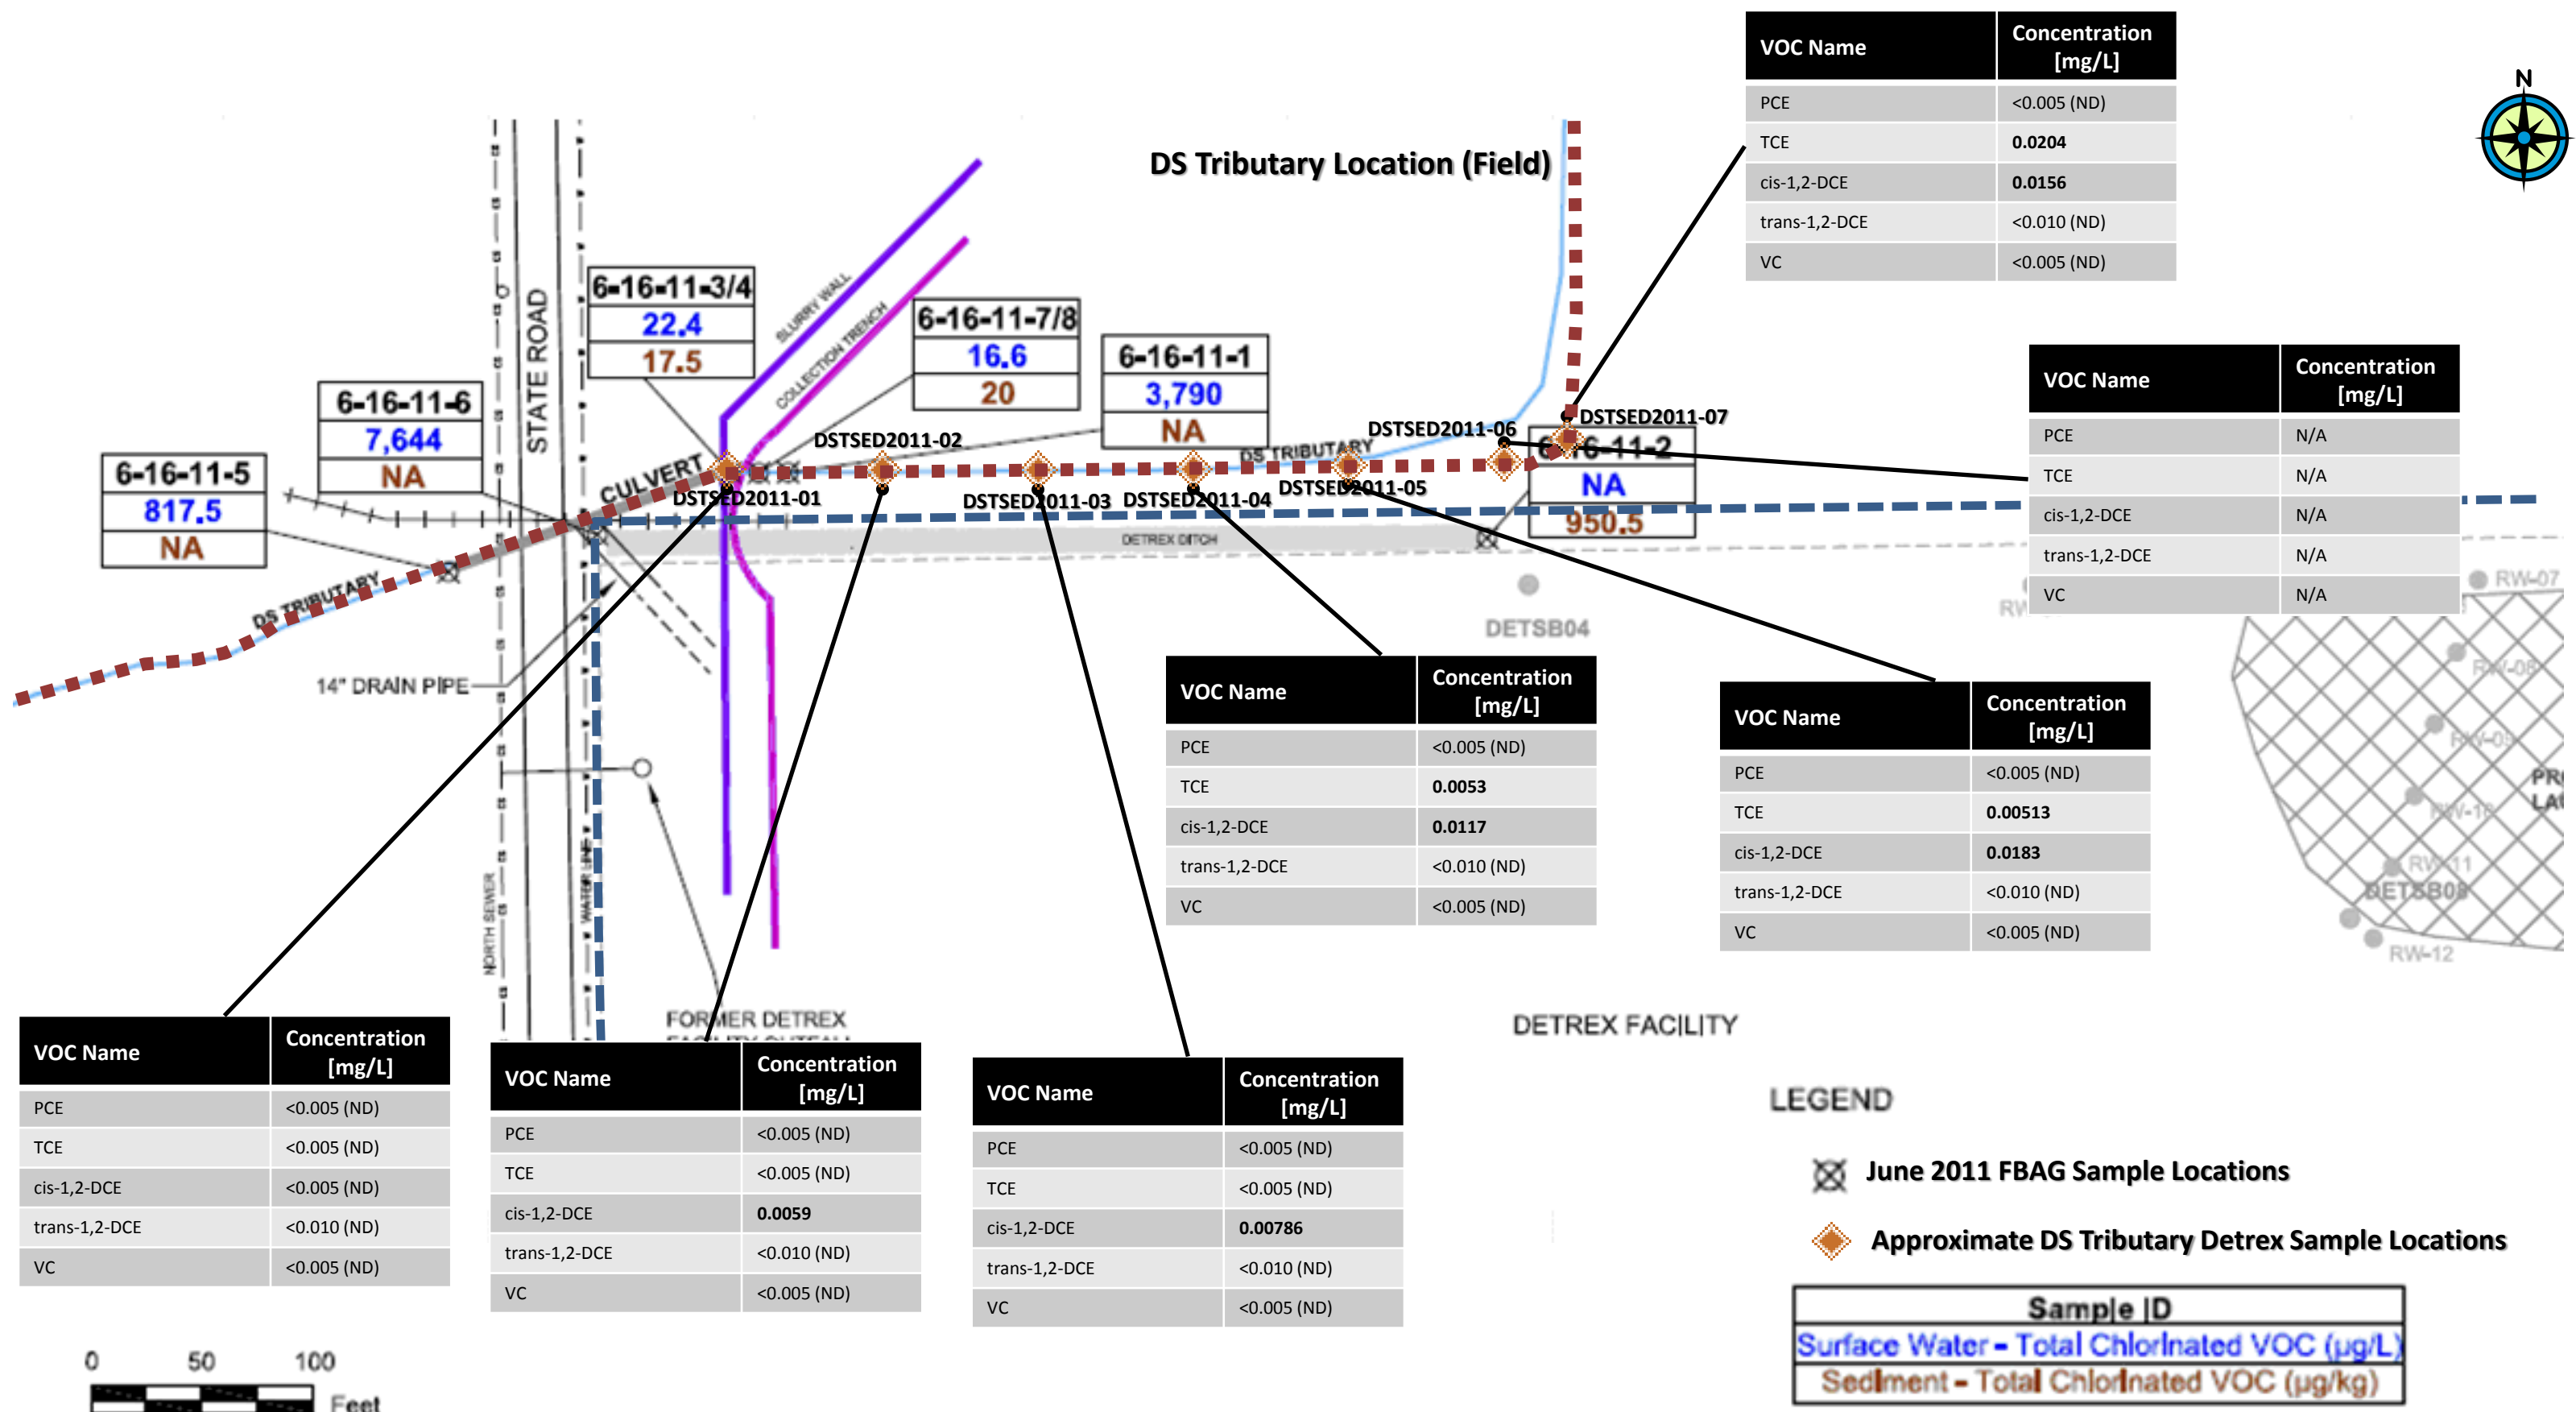
Figure 4

Based on the September 2011 sampling event it is noted that cis-1,2-DCE is consistently detected in all surface water samples except for DST SED 2011-01, with concentrations generally decreasing from DST SED 2011-07 to DST SED 2011-01 (i.e., upstream to downstream). TCE was the only other VOC detected in the surface water samples, and was limited to DST SED 2011-05 through DST SED 2011-07 at levels slightly higher than detection limits. No other VOCs were reported above detection limits in the surface water samples (see **Table 1 and Figure 4**).

Detrex Site – DS Tributary (East) SW Sampling Results

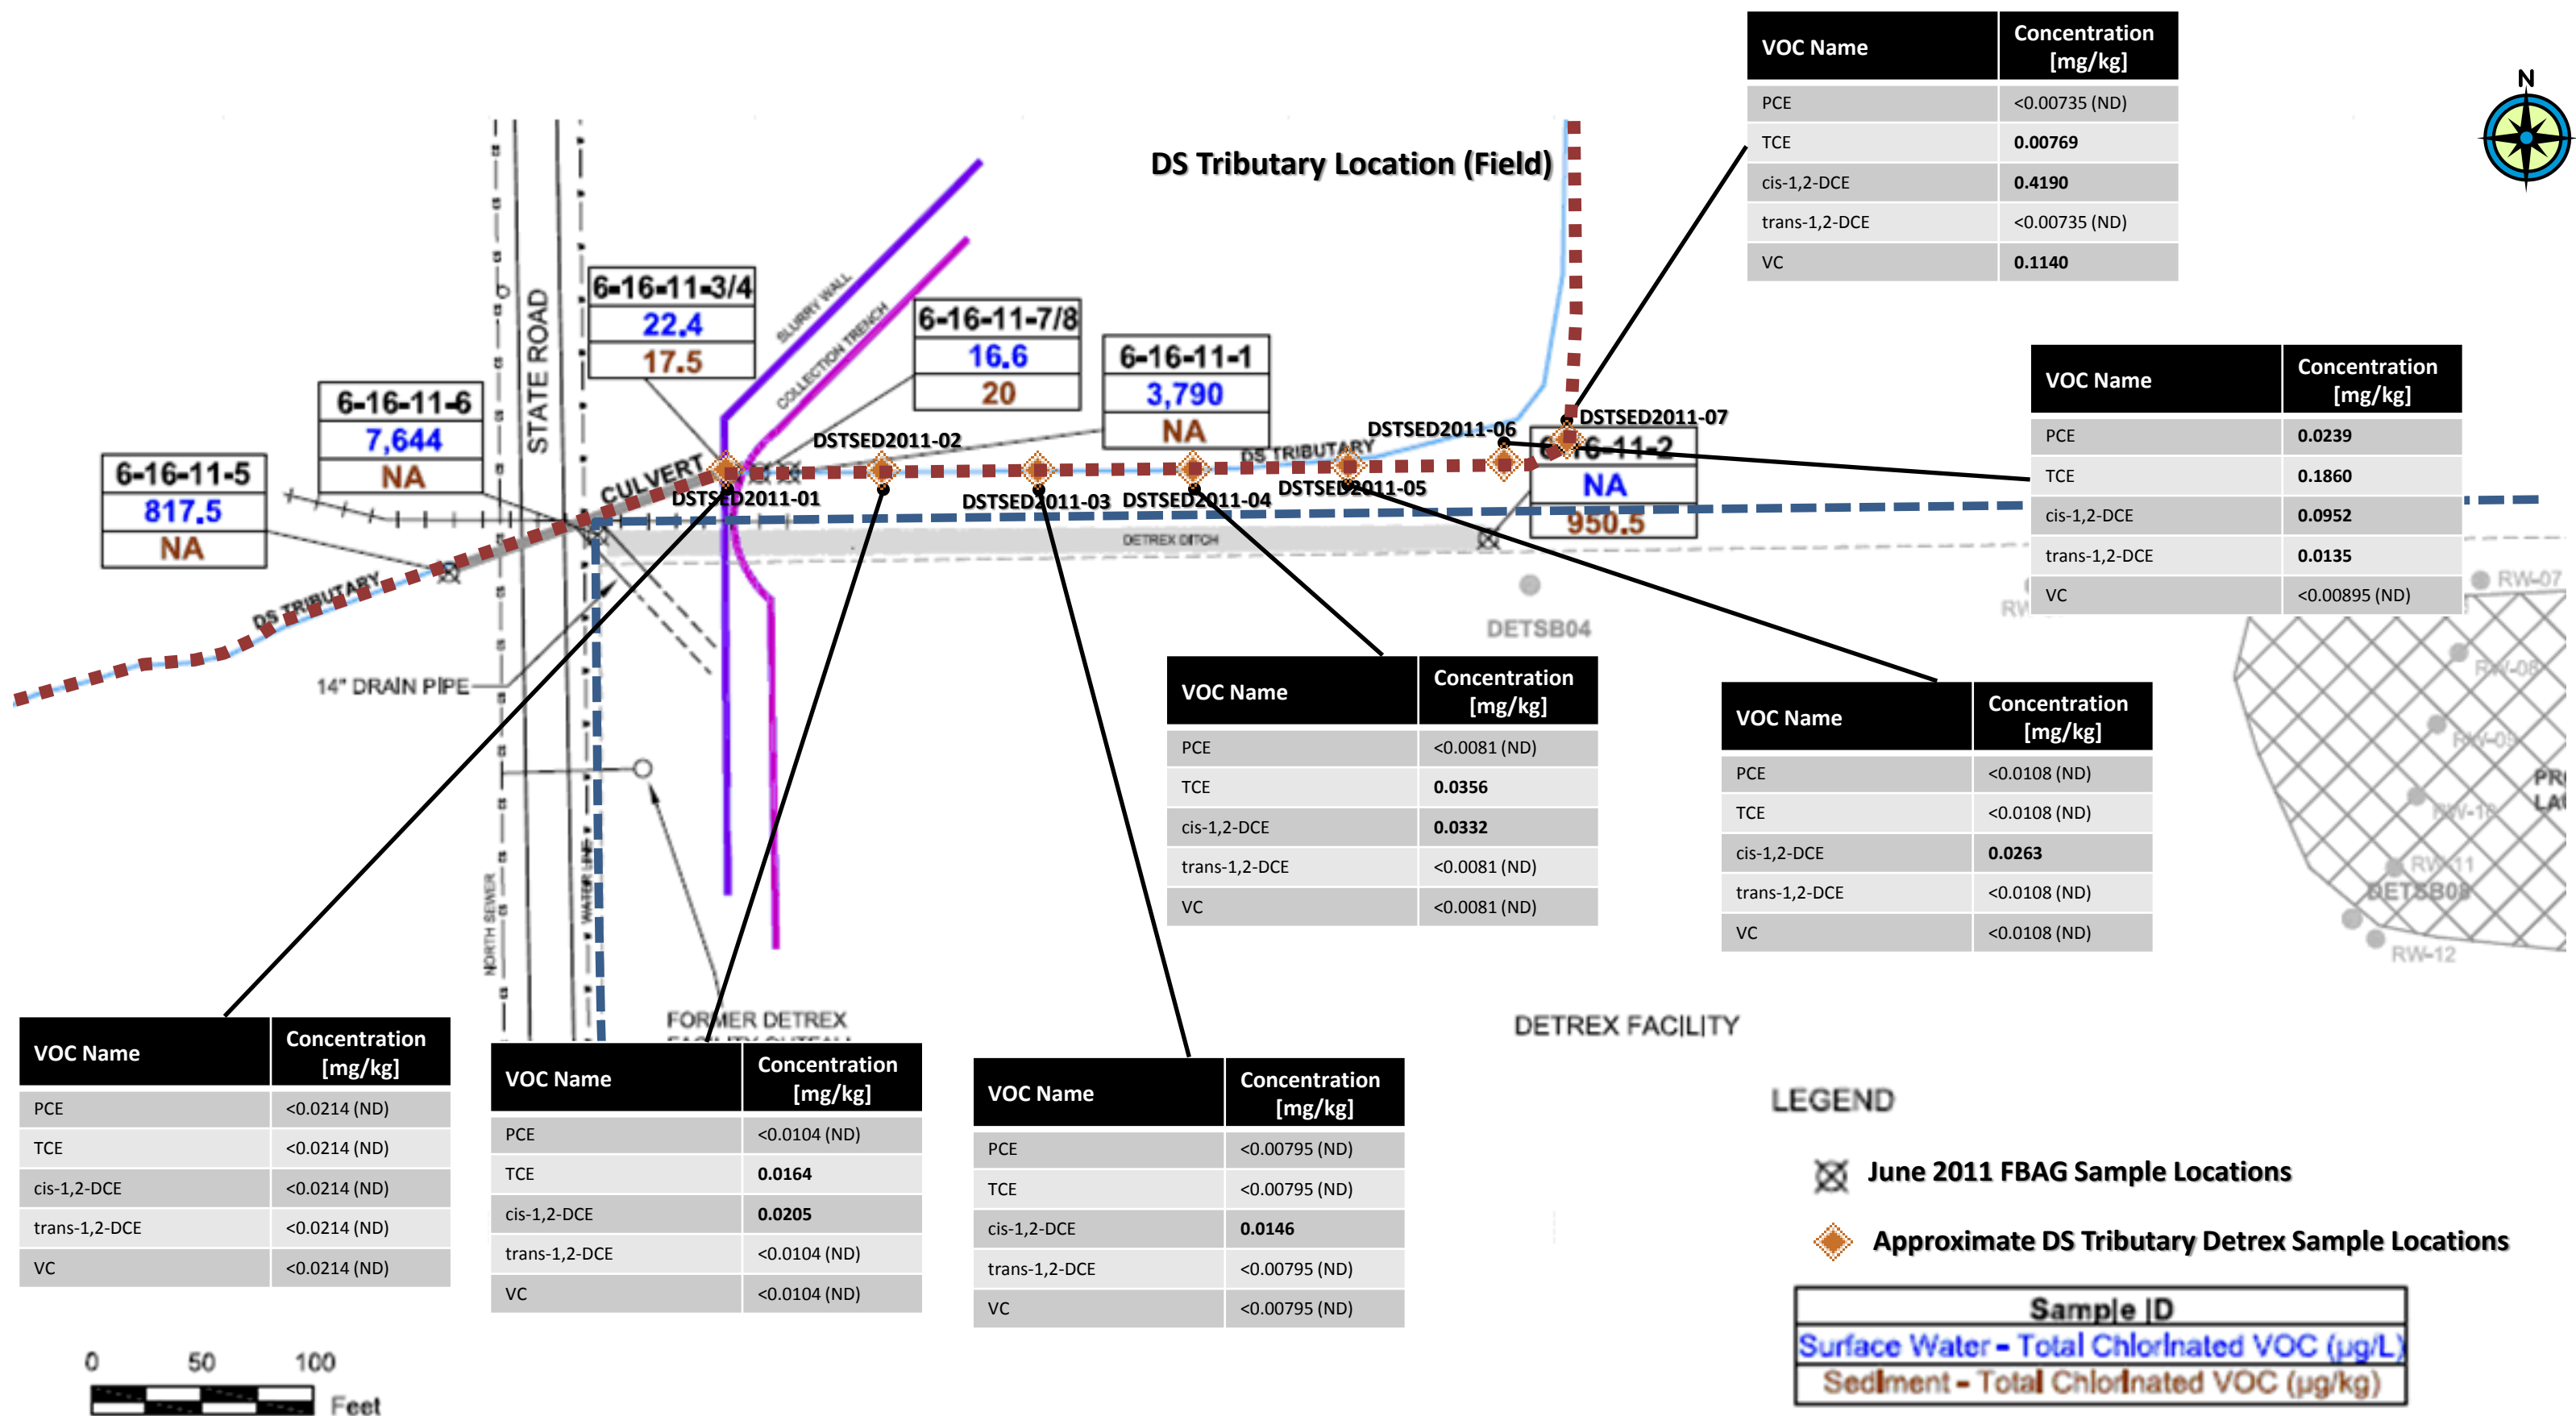
Figure 5

Similar results are observed for the sediment samples. Cis-1,2-DCE was reported in all sediment samples except for DTS SED 2011-01, with concentrations generally decreasing from DST SED 2011-07 to DST SED 2011-01 (i.e., upstream to downstream). As in the surface water samples, TCE was also detected in four sediment samples (i.e., DST SED 2011-02, -04, -06, and -07), with a general decrease as the locations get closer to State Road. For the sediment samples two other VOCs (i.e., trans-1,2-DCE and VC) were sporadically reported above detection limits. Trans-1,2-DCE was reported at DST SED 2011-06, and VC was reported at DST SED 2011-07 (see **Table 1 and Figure 5**).

Detrex Site – DS Tributary (East) Sediment Sampling Results

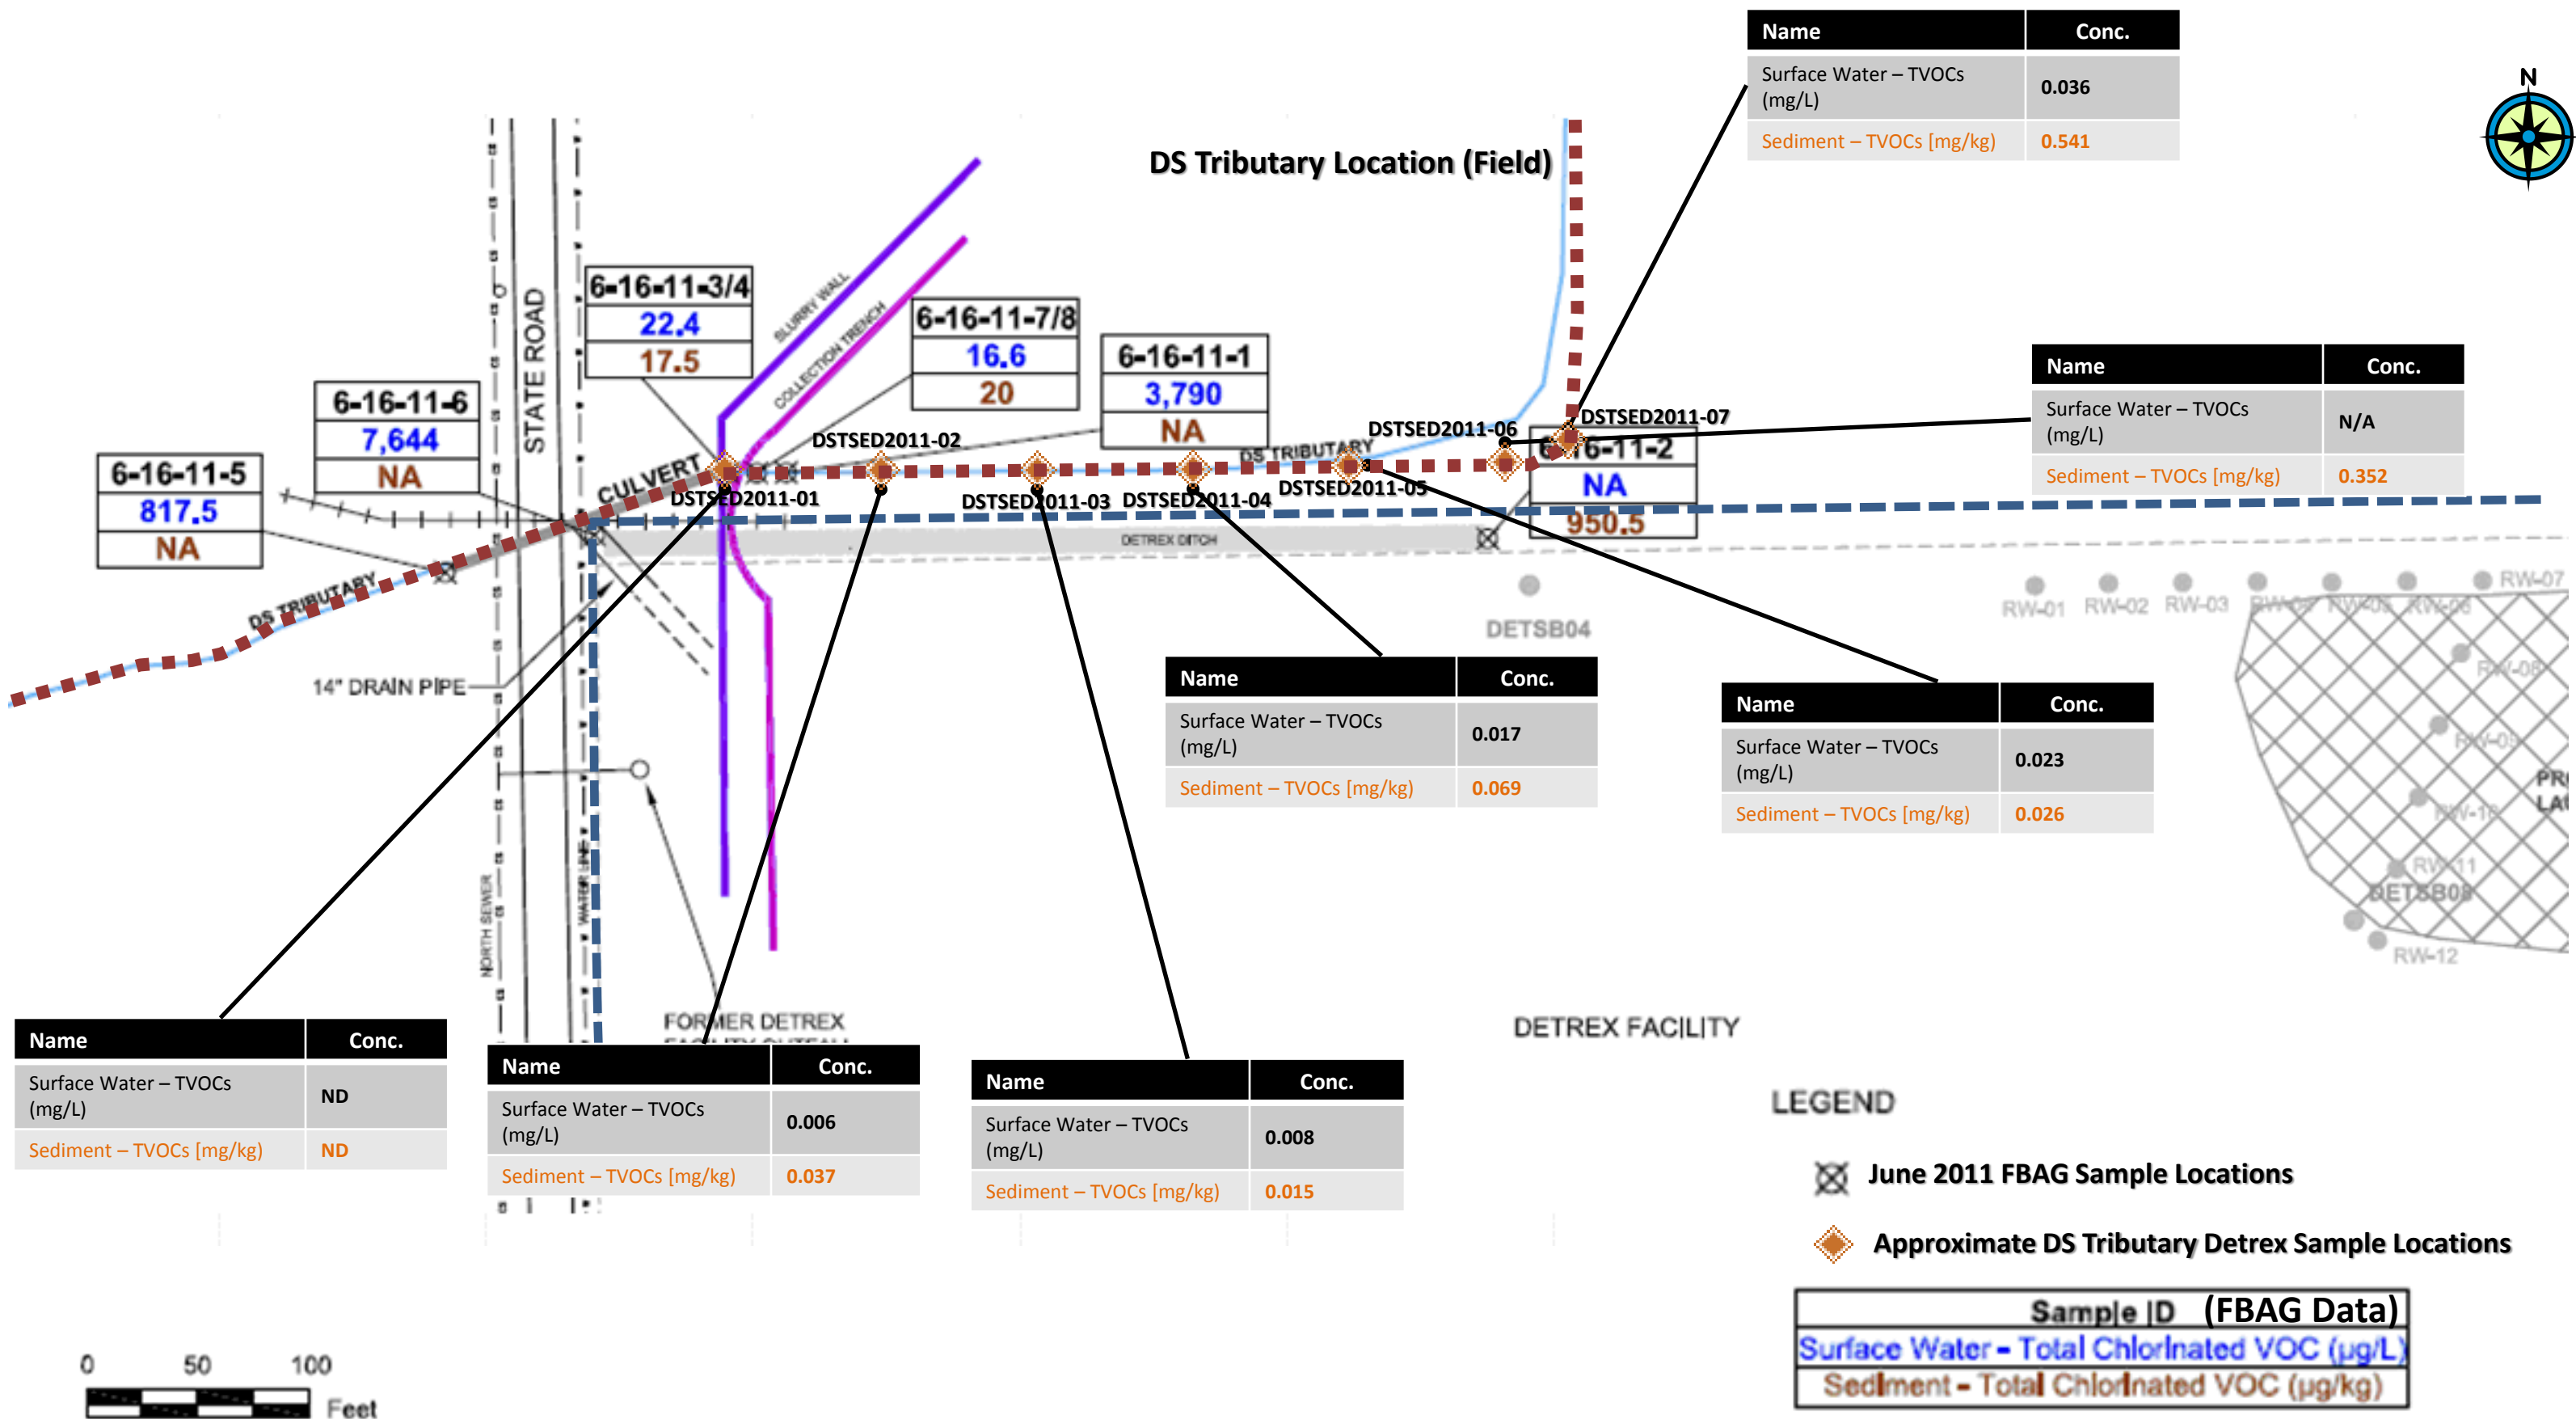
Figure 6

Combining all of the detectable VOCs to generate a total VOC number provides some additional insight into the VOC distribution, as it is noted that the total VOC values decrease from the farthest upstream sampling point at DST SED 2011-07 to non-detect (ND) at DST SED 2011-01 (see **Table 1 and Figure 6**).

Detrex Site – DS Tributary (East) Sediment/SW Sampling Results
